# Electric Transmission Overhead Steel Structure Strategy Overview

Transmission Overhead Steel Structure Strategy - 2017

## STRUCTURES

**Prepared by: Quanta Technology  
May 2010**

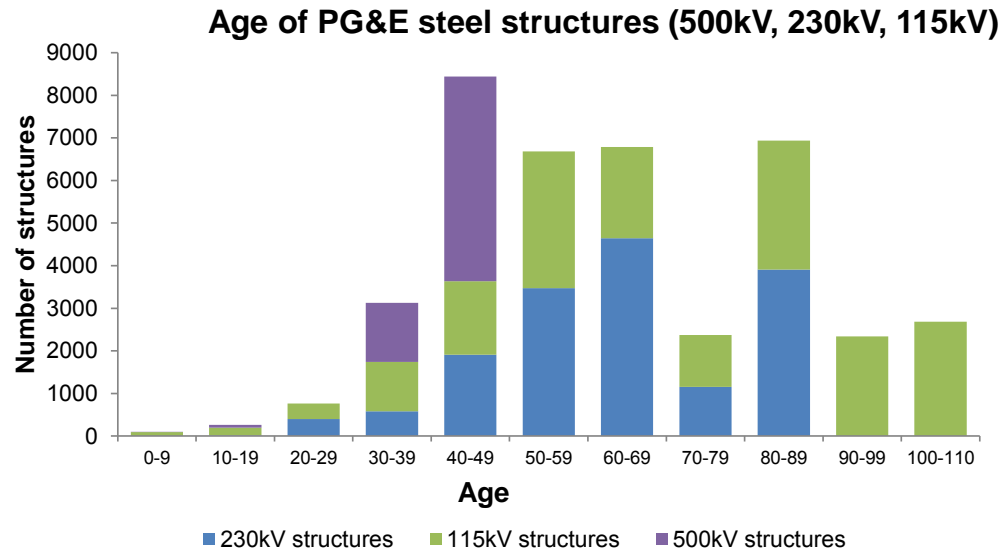
## Asset Base – Steel Structure In Service

- Oldest structures are 108 years old, average age is 68
- Mean Life Expectancy is 65 years
  - Max Coastal: 80 years
  - Max Valley: 100+ years
- Poor age data on 60 and 70 kV structures
- Structures age data/life expectancy is from a year 2010 Quanta Technology Study

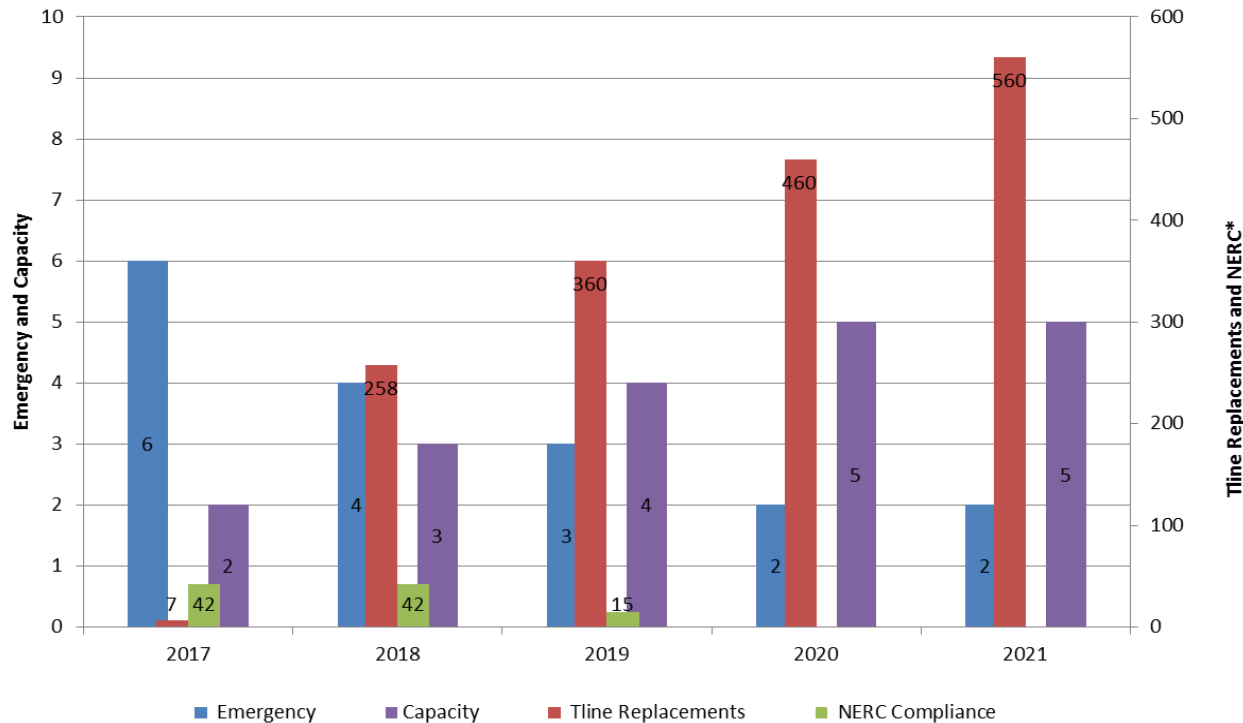
### Transmission Steel Structures Average Installations Next 5 years

- Transmission line Replacement Ramp up is due primarily to recent asset condition assessments, asset failures from the recent 2017 storms, and asset deterioration from field input.

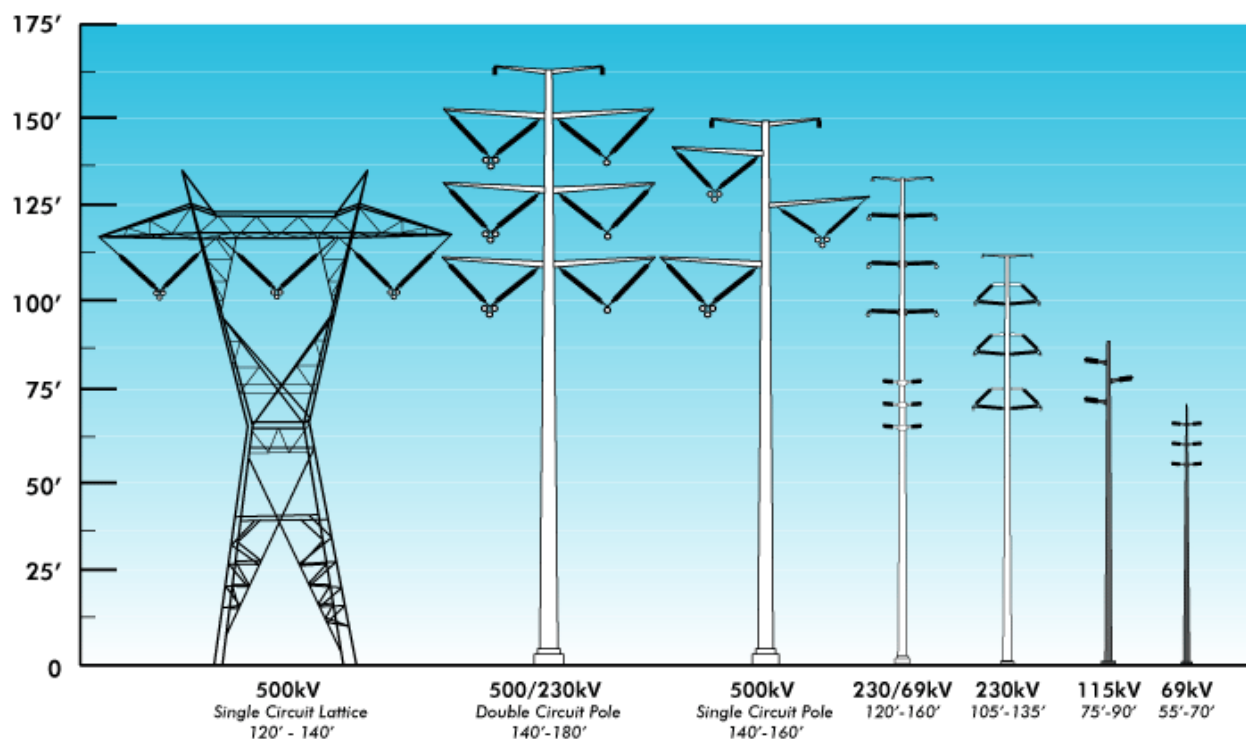
Figure 3-1. Typical industry tower types and heights by voltage class.

Steel towers are generally manufactured from high strength steel producing an economical and easily constructed tower. These towers can be offered in several sizes and designs and also provide improved appearance, high reliability and reasonable maintenance cost. Transmission steel towers are applicable for either high voltage DC or AC transmission systems and may be designed to carry single or double electrical circuits. Steel towers may be installed in various terrains, environmental, and climate conditions. Additionally, steel towers can be designed as self-supporting structures for applications where wood poles are required to be guyed.

ronments. Other advantages of tubular steel poles are as follows: Aesthetically pleasing, compactness, reduced right of way, non toxic, fully recyclable, minimal maintenance and inspection cost, and sometimes lower cost than lattice tower towers. A disadvantage of the tubular steel poles may be overall strength limitations of the structure which is proportional to the diameter of the tower.

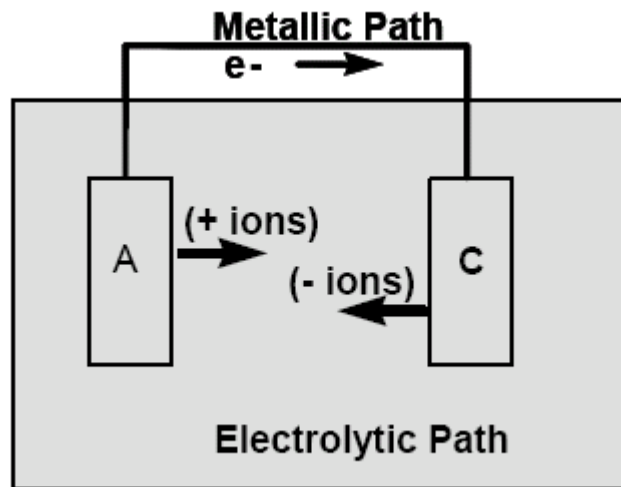
**Figure 4-1. Typical Corrosion Cell**

In a corrosion cell, electrons migrate from the anode to the cathode leaving a surplus of positively charged ions that combine with negatively charged hydroxyl ions in the solution to produce corrosion oxides. A typical corrosion cell is shown in Figure 4-1.

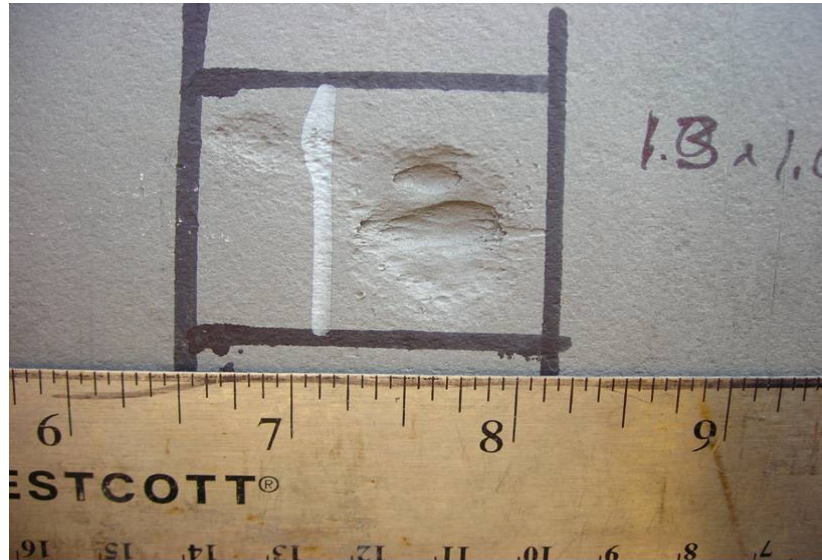
**Figure 4-2. Corrosion Caused by MIC**

Establishing a reasonably conservative estimate of corrosion growth rates requires consideration for unique circumstances where corrosion of underground and submerged structures may be greatly accelerated. Such conditions include evidence of microbially influenced corrosion (MIC), corrosion caused by stray direct current and corrosion caused by induced alternating current. MIC in soils has been documented to occur at rates approaching 6mm/yr. (0.150in/yr (150mpy)). An example of the corrosion morphology associated with MIC is shown in Figure 4-2.

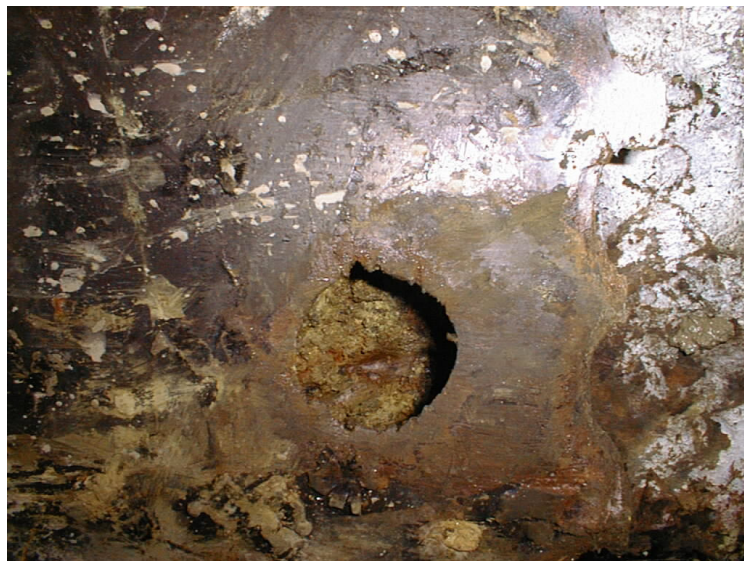
**Figure 4-3. Corrosion Caused by Stray D-C**

The effects of stray direct current (DC) on established corrosion rates cannot be readily quantified due to the significant metal removal power of DC currents. Rates of 10mm/yr (250mpy) are expected. An example of the corrosion morphology associated with DC interference current is shown in Figure 4-3.

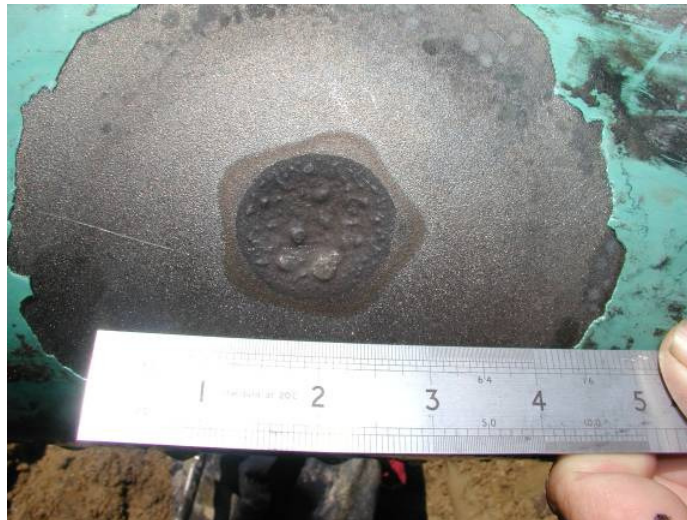
**Figure 4-4. Corrosion Cause by Stray A-C**

corrosion requiring pinhole defects in coatings to concentrate the current density. An example of the corrosion morphology associated with AC interference current is shown in Figure 4-4.

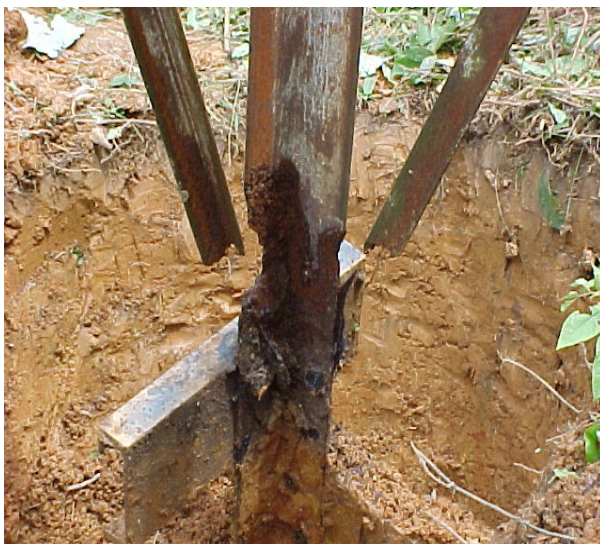
At the atmospheric to below ground transition, corrosion cells are established due to the abundant availability of oxygen and moisture in the transition between above and below grade.

Prevailing rains can concentrate atmospheric pollutants due to ponding of rainwater in this immediate region. This ponding establishes differing chemical environments in contact with the same structural member as well as establishes corrosion cells with adjacent tower legs.

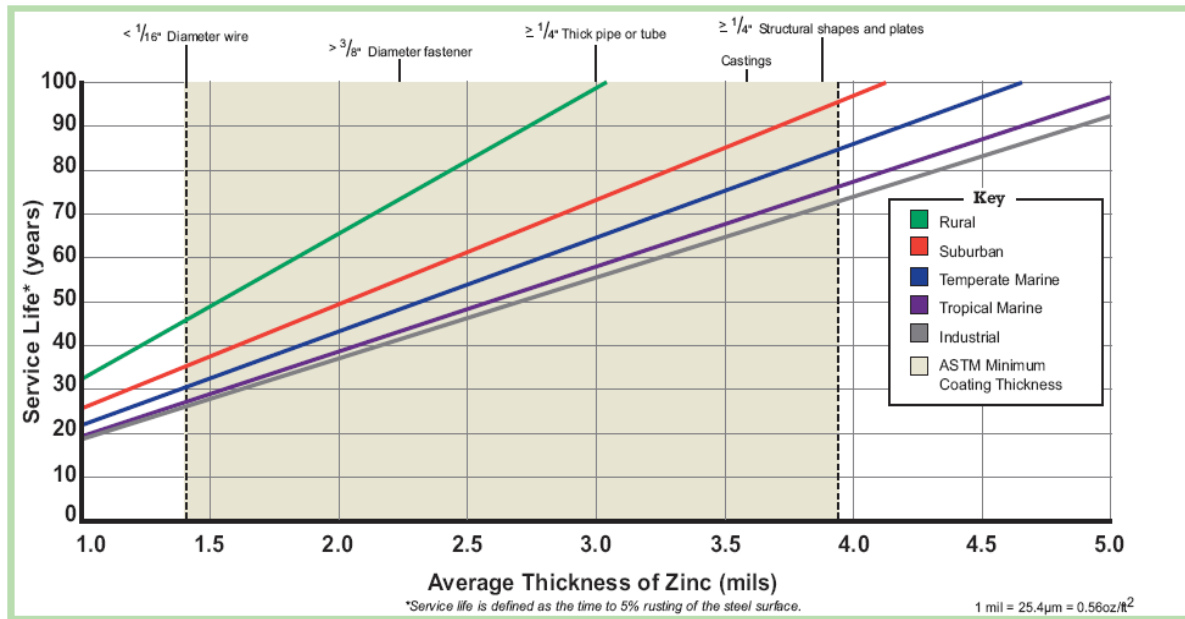
**Figure 7-1. Service Life of Hot-Dip Galvanized Coatings**

As corrosion is the most prevalent cause of deterioration of steel structures, the life expectancy of the original coating of the steel is critical to the long term health of the structure. The American Galvanizers Association regularly produces life expectancy data on hot-dip galvanized coatings, the predominant coating for steel structures. Figure 6-1 displays life expectancy information for a hot-dip galvanized coating in a variety of environments. The service life for this chart is defined as the time until 5% rusting of the steel structure is experienced.

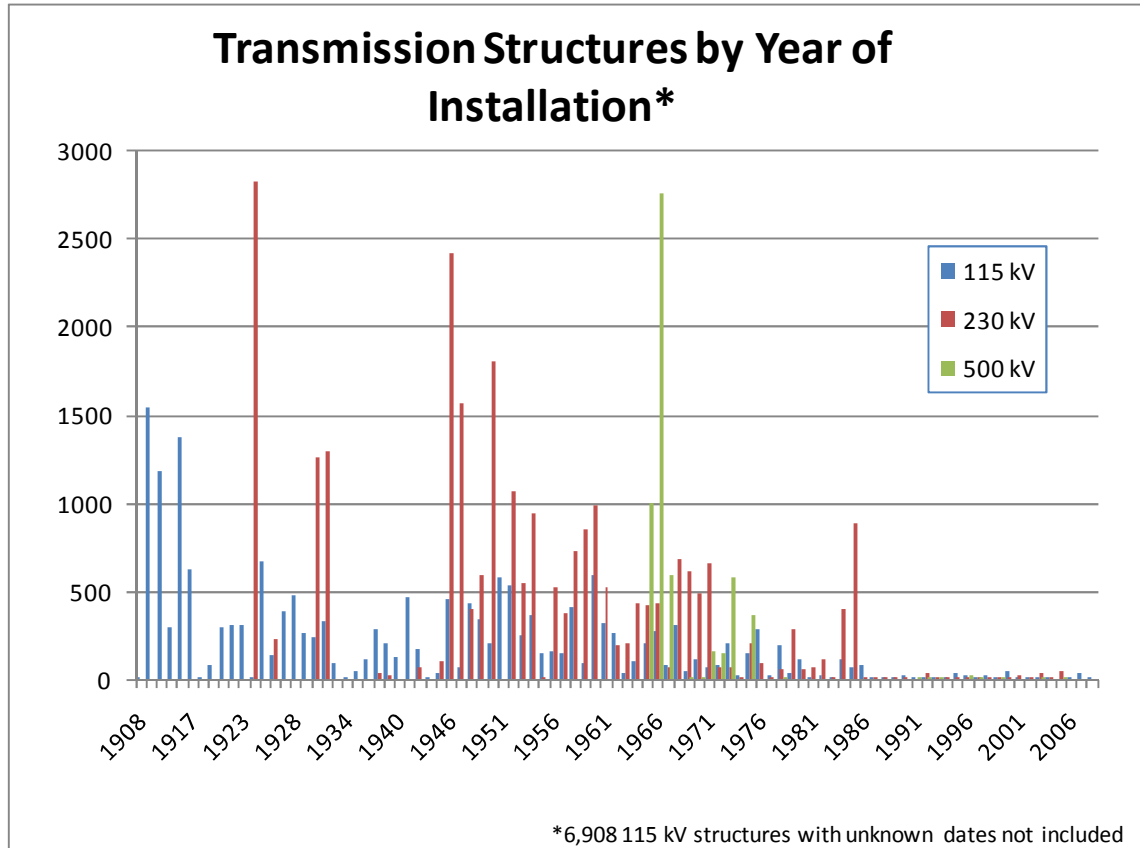
**Figure 9-1. Age distribution of transmission structures**

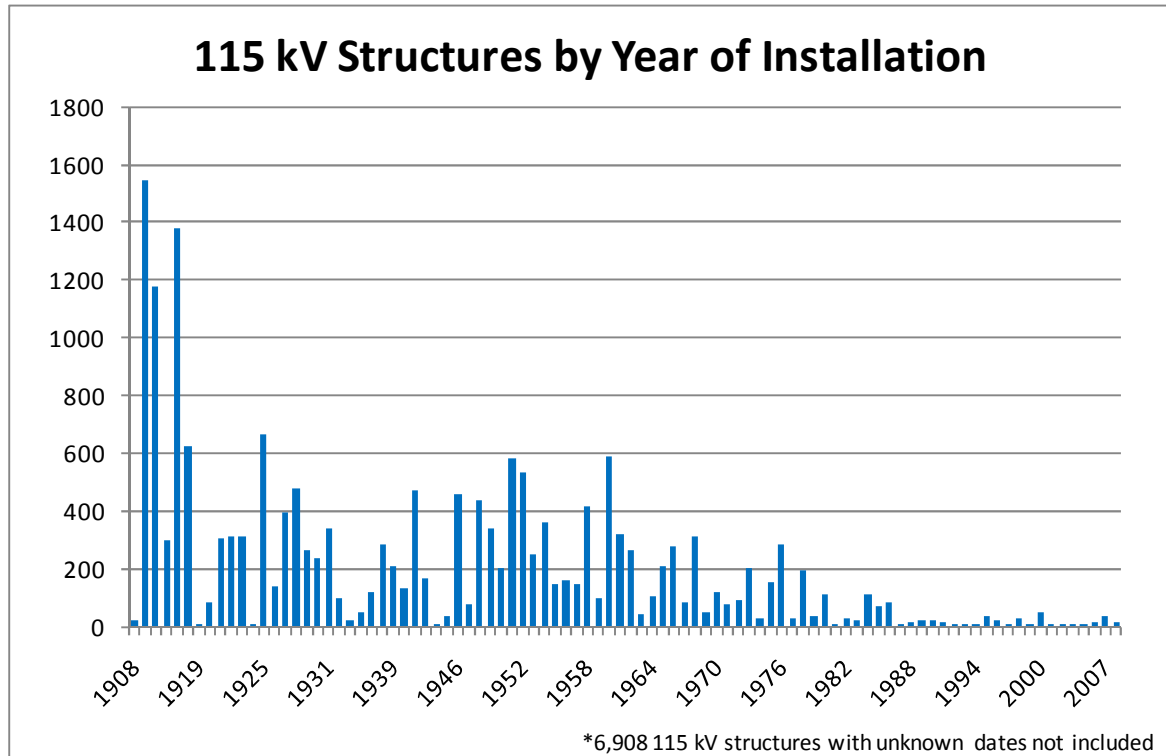
Figure 9-2. 115 kV structures by year installed

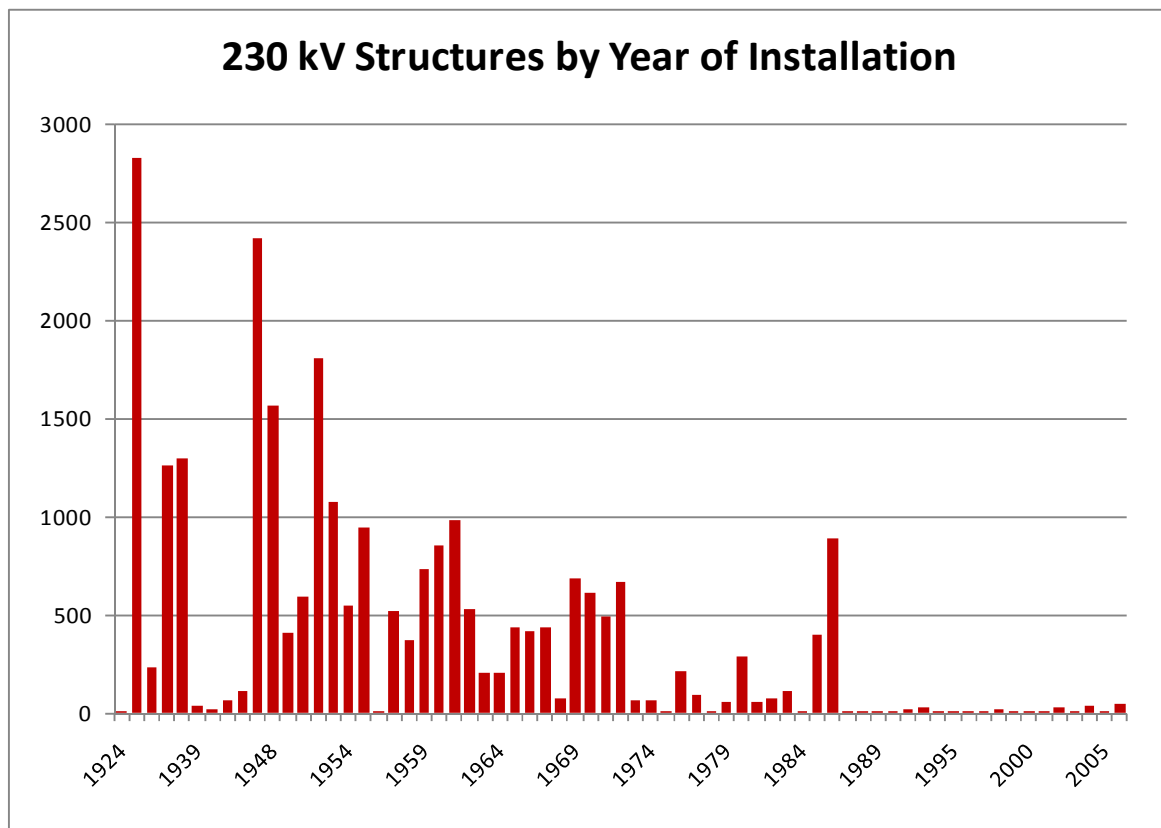
Figure 9-3. 230 kV structures by year installed

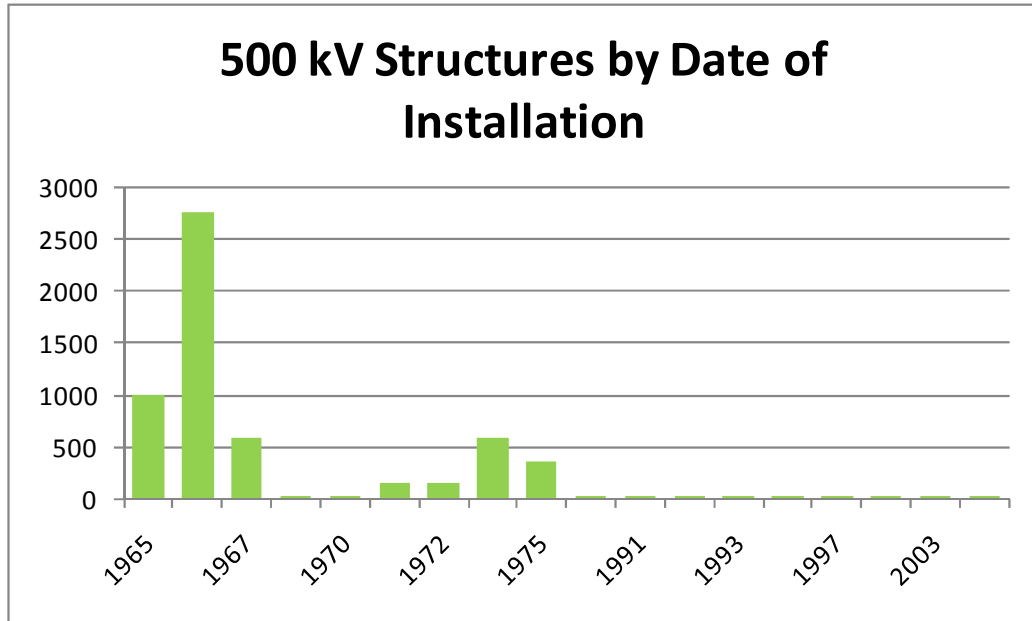
**Figure 9-4. 500 kV structures by year installed**

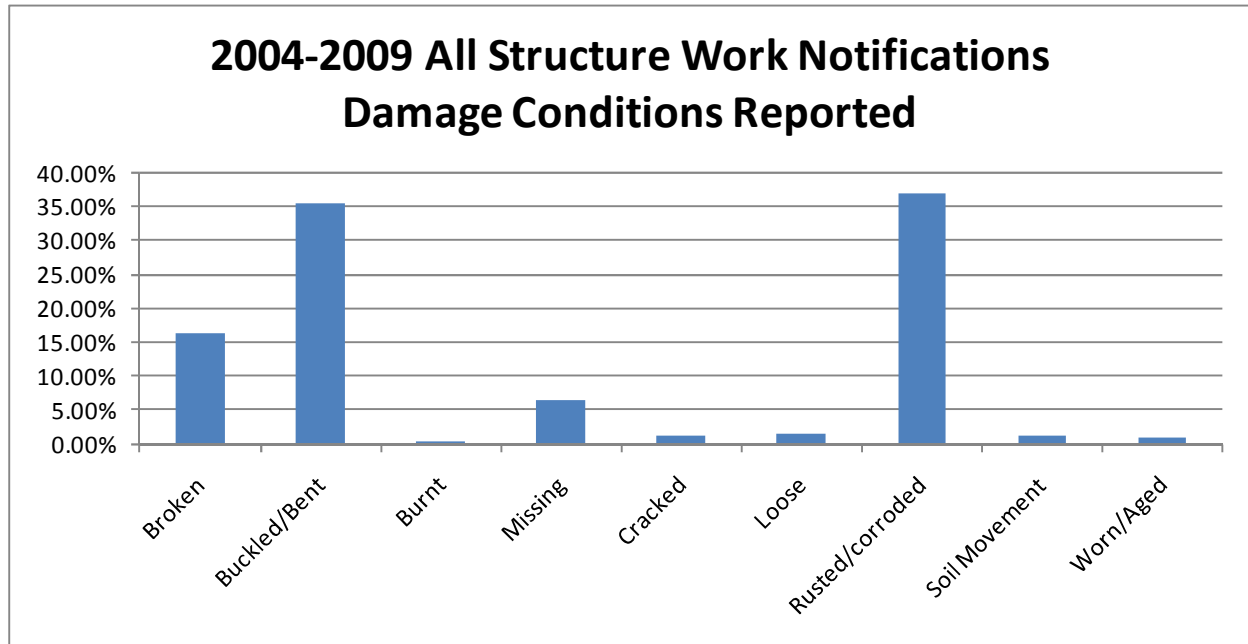
**Figure 9-5. Damage codes reported**

For the period January 2004 through April 2009 there are approximately 11,500 work notifications, both pending and complete, on transmission structures. A high percentage (~77%) of the work notifications report missing steps, anti-climbing guards, or platforms. The remaining 23% of the notifications report various damage conditions found on the structures that are considered for this analysis to be associated with the structural condition of the towers. This population of work notifications is approximately 2,600 in number and the distribution of the types of damage reported is shown in Figure 9-5.

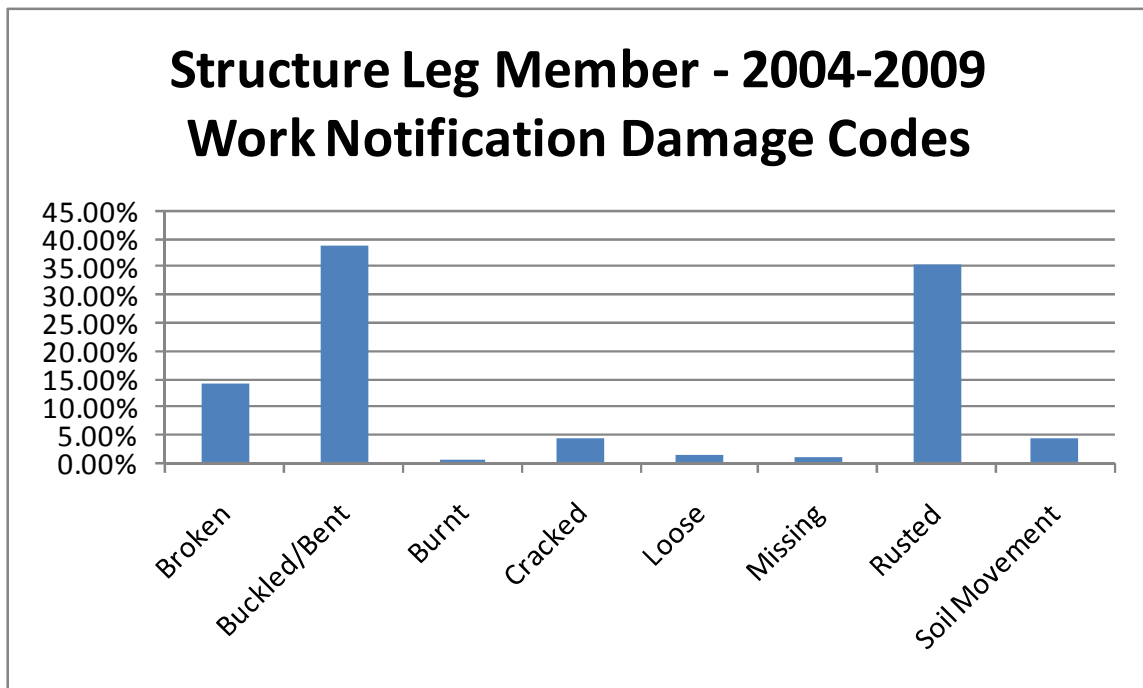
**Figure 9-6. Leg member damage reports**

Review of the damage conditions reported by different structure components reveals a damage condition distribution as shown in Figures 8-6 through 8-8.

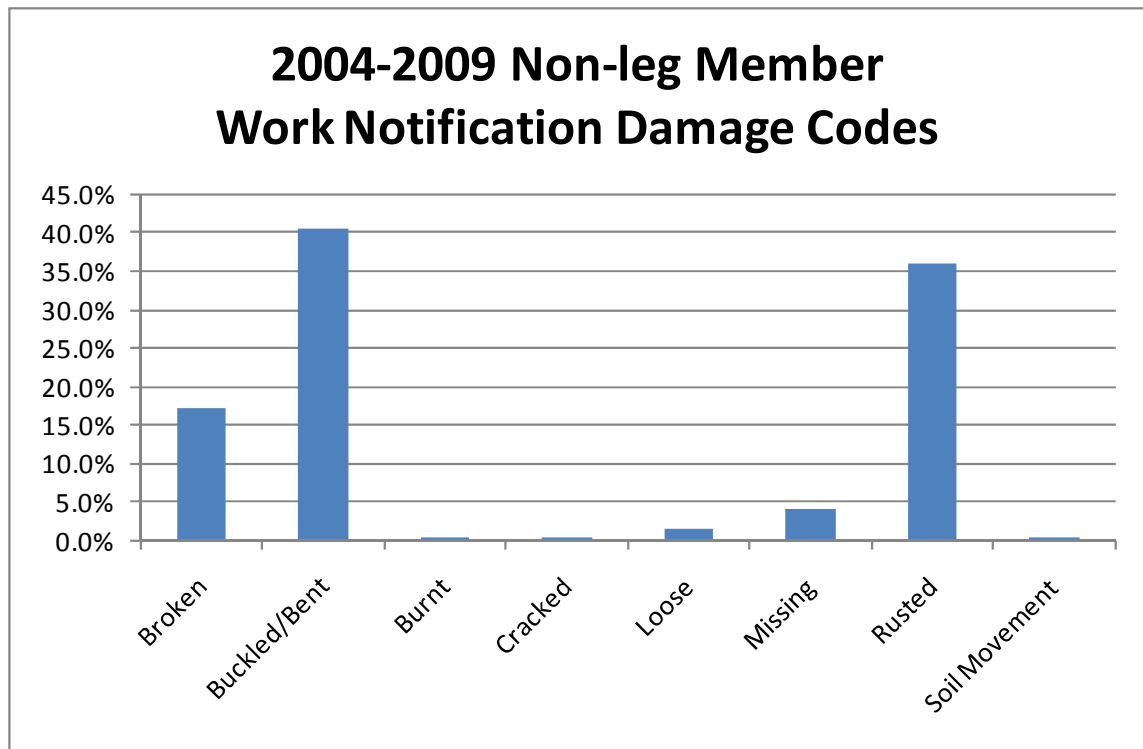
Figure 9-7. Non-leg member damage reports

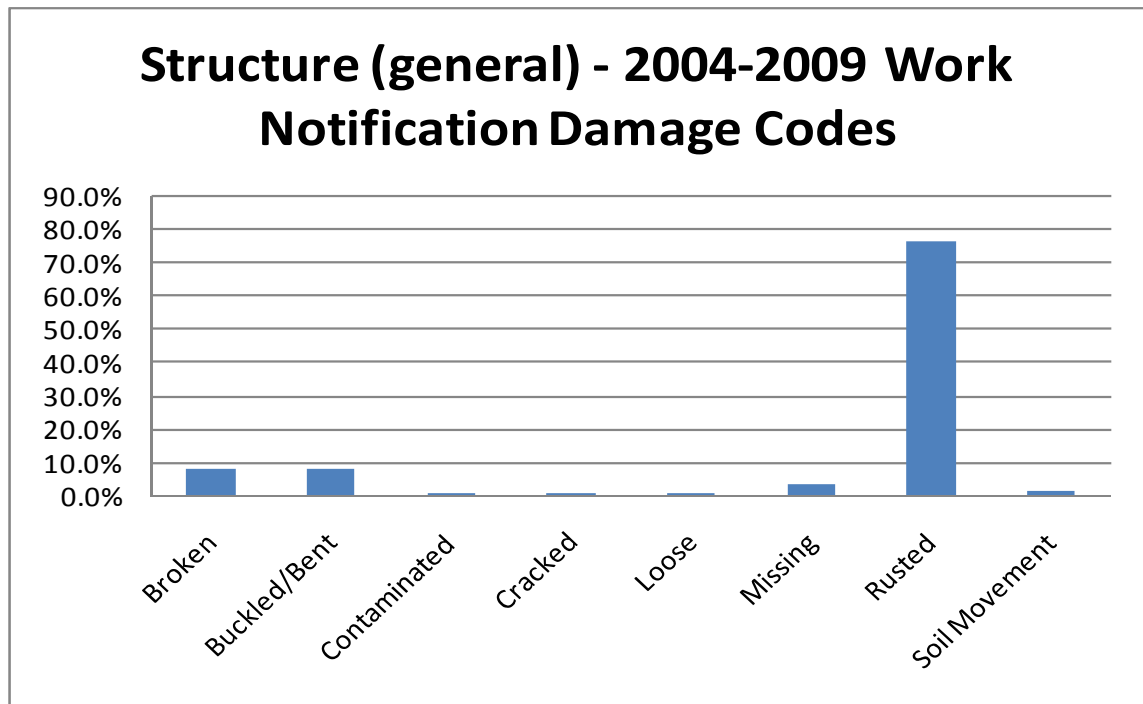
Figure 9-8. Structure (general, incl. bolts) damage reports

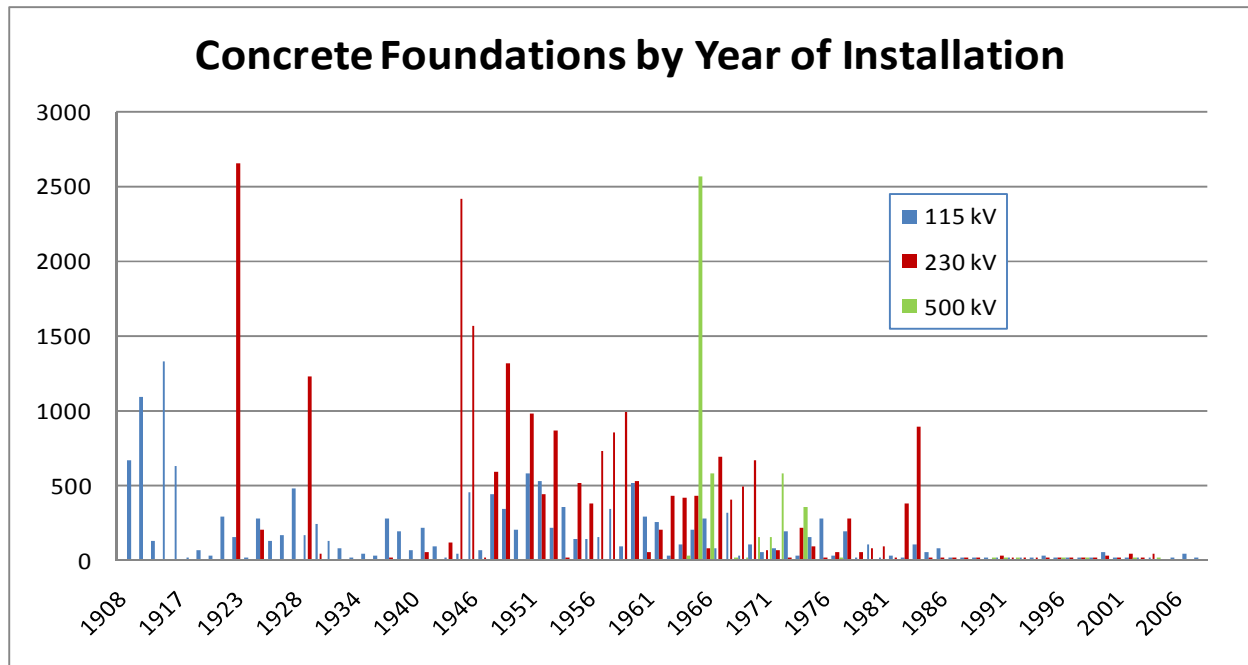
Figure 9-9. Concrete foundations

The following graphs display the age distribution of foundations, by type. The total numbers represented are as follows: Concrete 42,330; Earth 5,072; Pile 1,978.

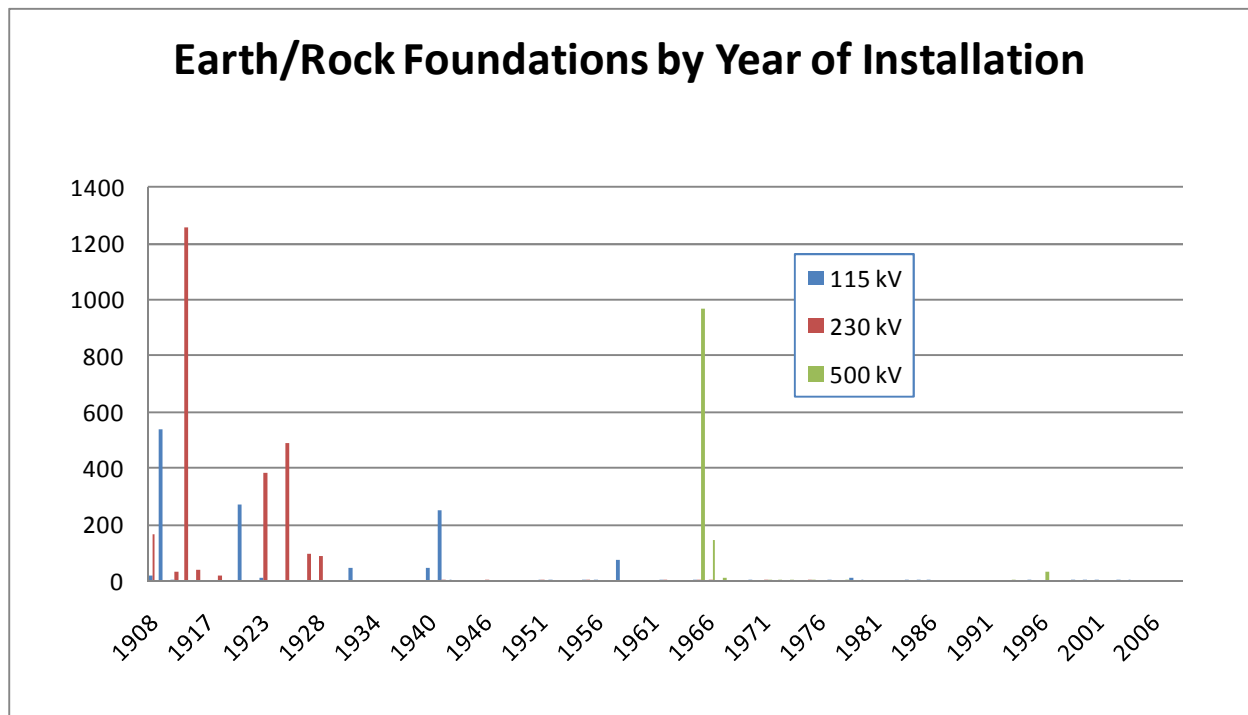
Figure 9-10. Earth and rock foundations

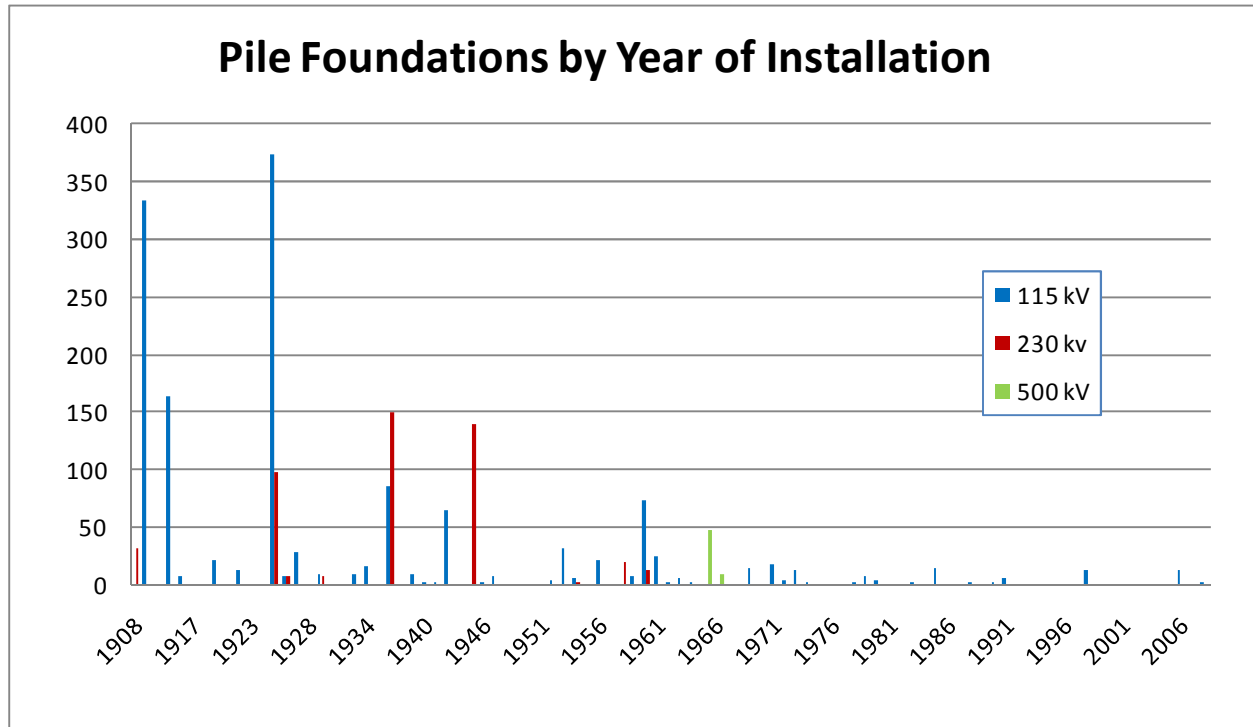
Figure 9-11. Pile foundations

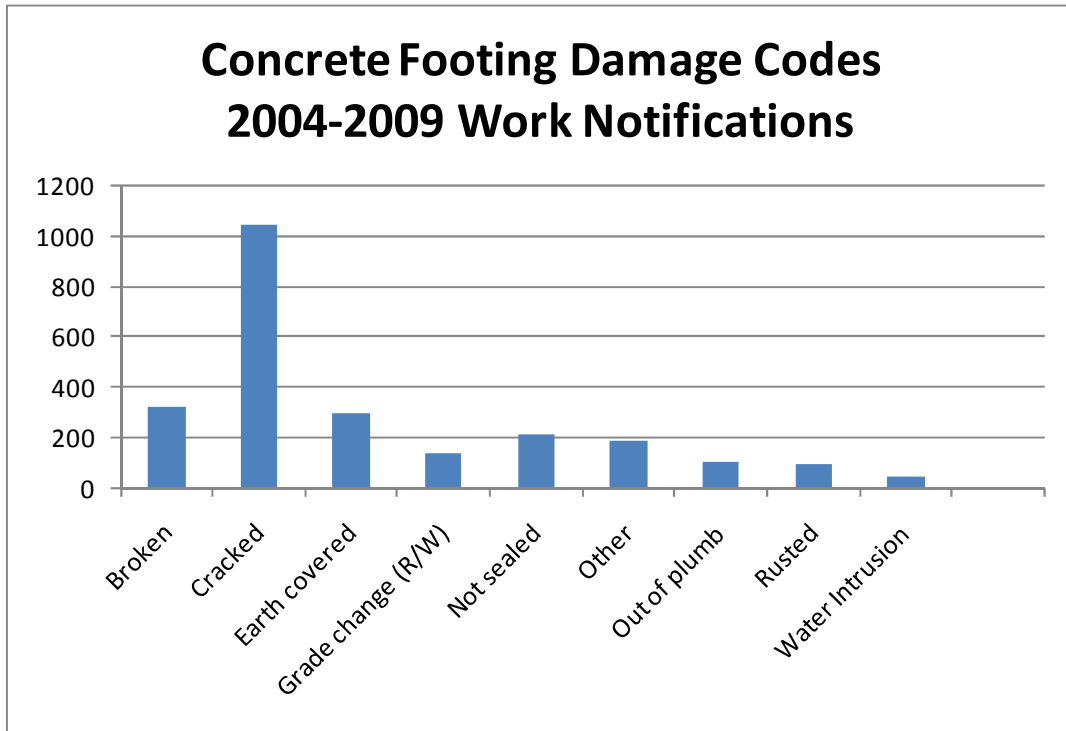
Figure 9-12. Concrete footing damage reports

The following graphs show distribution of foundation damage codes. The total number of concrete footing records reported was 2,443 and earth footing records totaled 189.

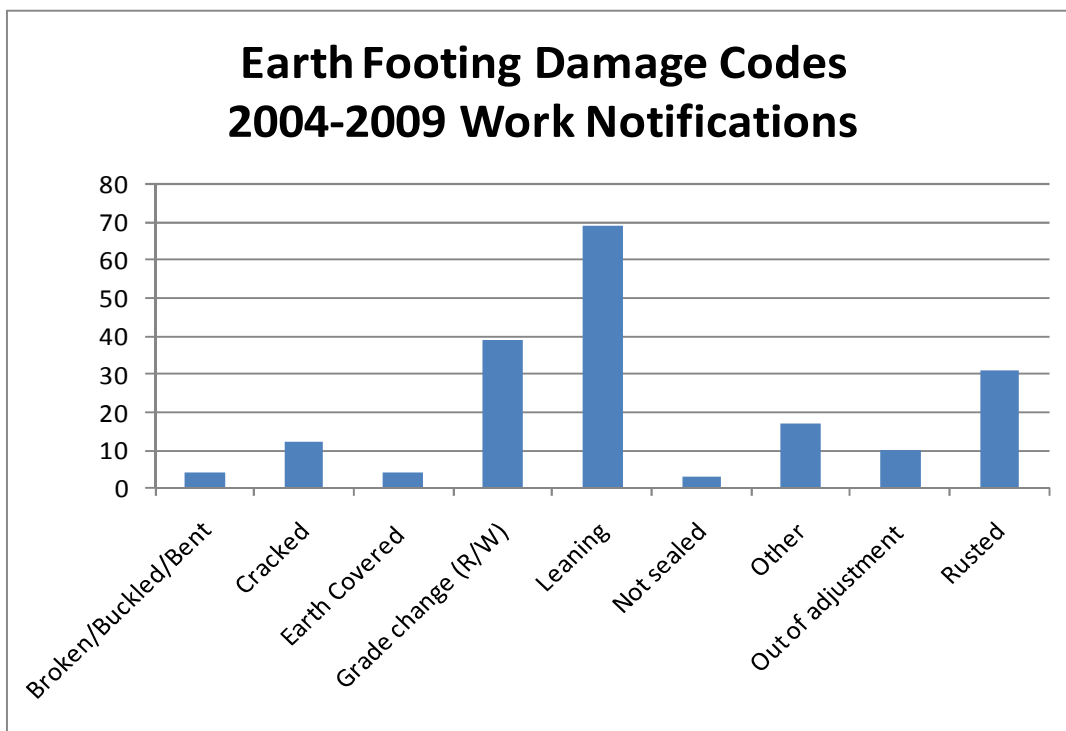
Figure 9-13. Earth footing damage reports

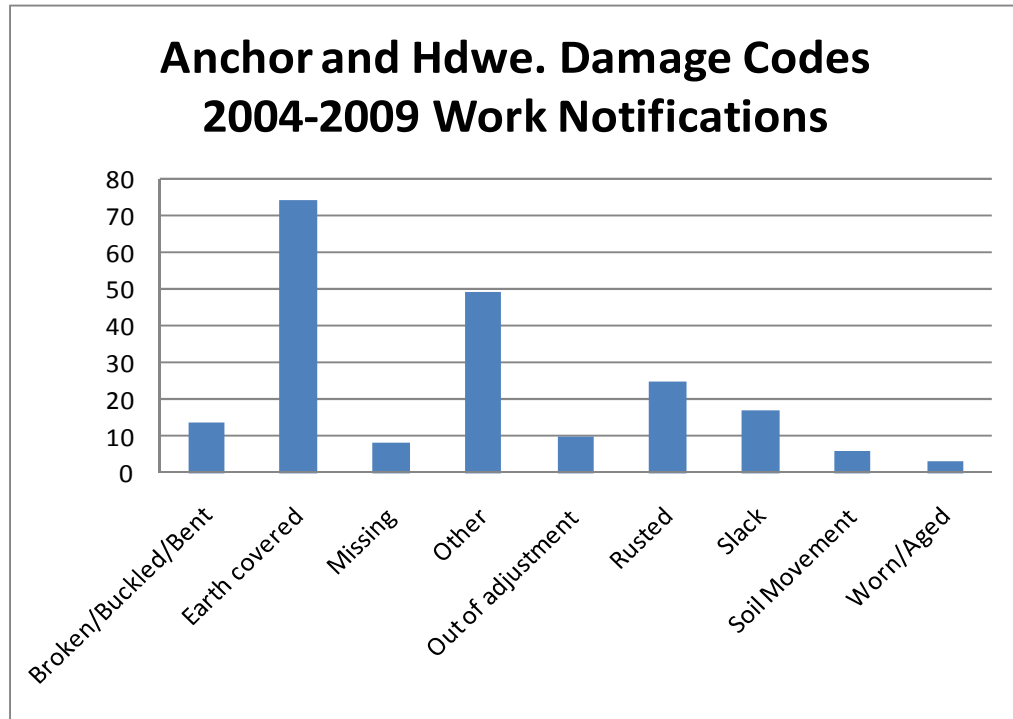
Figure 9-14. Anchor and anchor hardware damage reports

The following graphs show distribution work notification damage codes for anchors and hardware and guys as taken from 2004-2009 work notifications. The number of anchor/hardware records was 206 and guy records totaled 593.

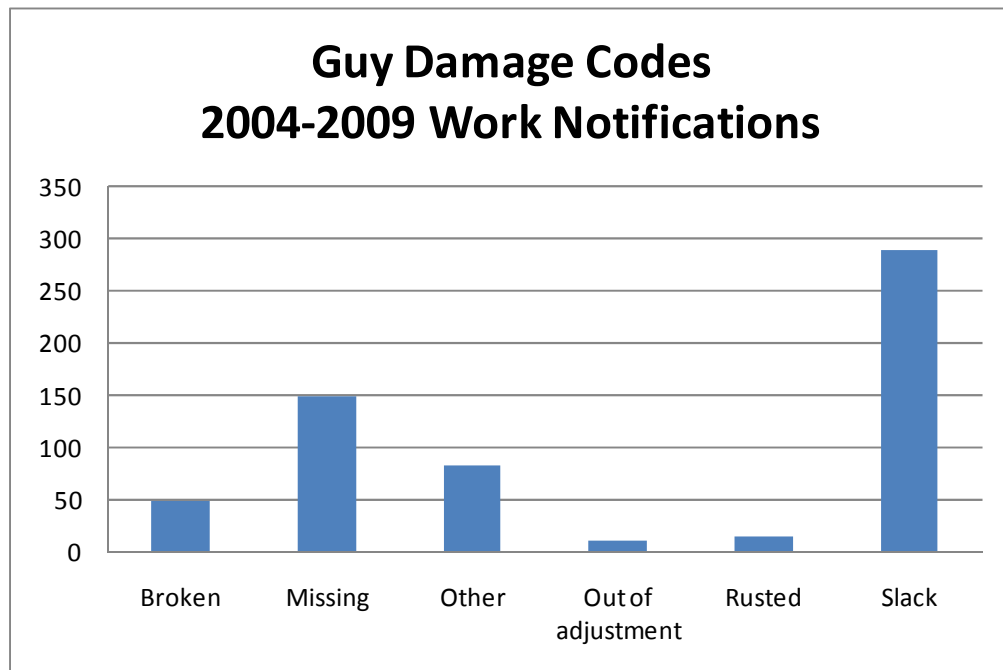
Figure 9-15. Guy damage reports

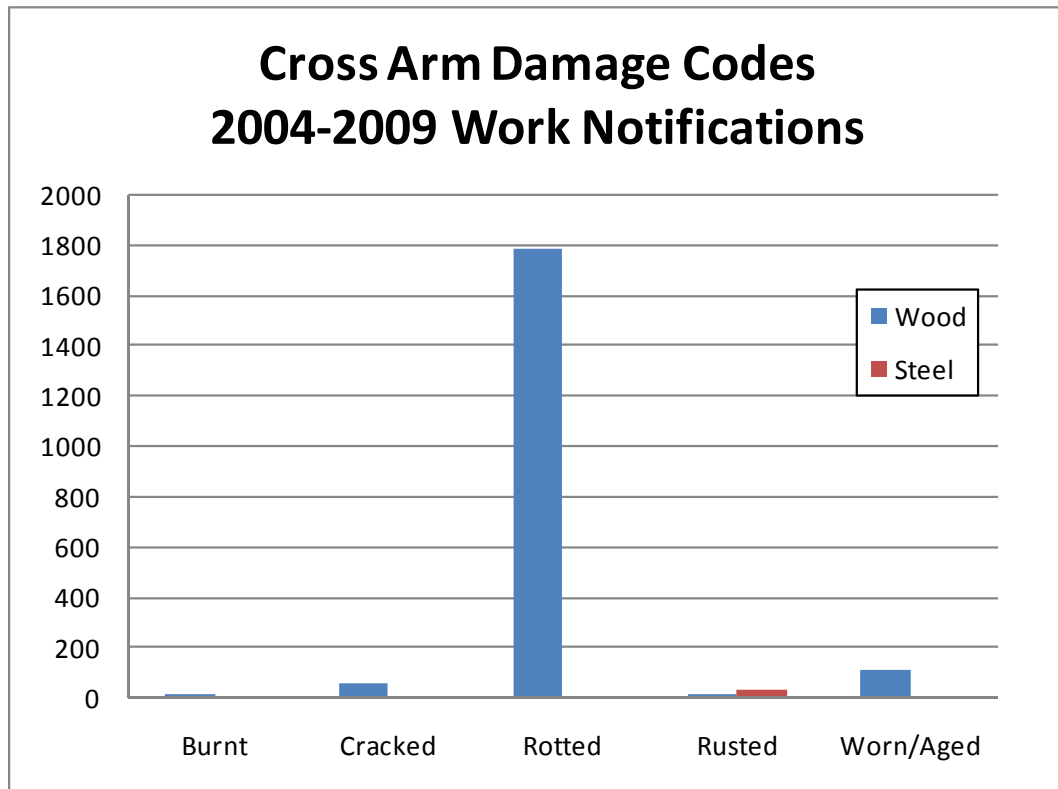
**Figure 9-16. Cross arm damage reports**

The following graphs show distribution of damage codes for wood and steel cross arms as taken from 2004-2009 work notifications. The total number of wood cross arm records was 1990 and steel was 34.

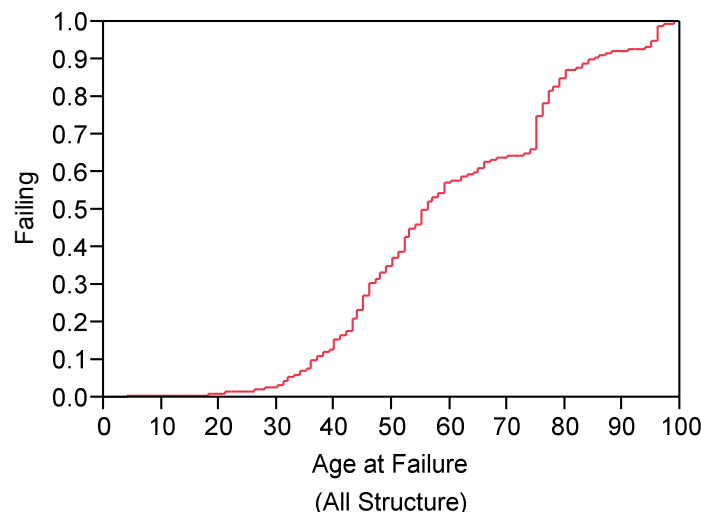
**Figure 10-1. The Kaplan Meier plot of all structure failure data**

The Kaplan Meier plot is shown in Figure 10-1, this plot can be treated as a cumulative distribution function based on actual data instead of a fitted probability distribution function. Considering only the set of structures that have experienced a major failure from 2004 to 2008, the plot describes the probability that these failures have occurred before or at the time  $t$ .

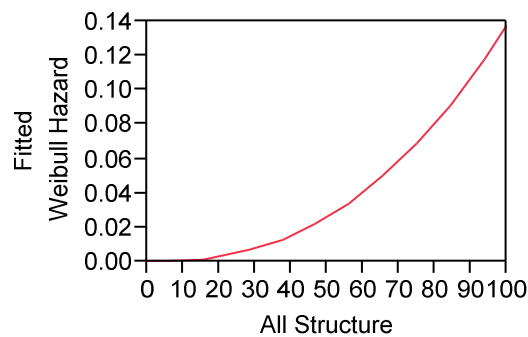
**Figure 10-3. Fitted Weibull hazard function for structures**

As shown in Figure 10-3, the typical failure rate of a structure increases with its age. Based on the fitted Weibull distribution, the typical failure rate of a structure of age 90 is around 0.11.

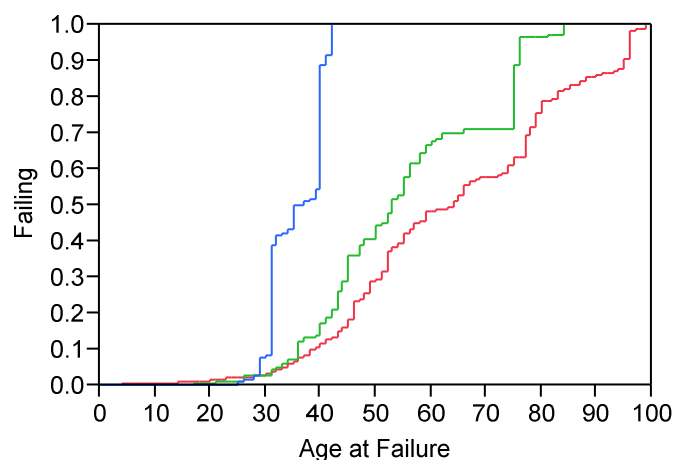
**Figure 10-4. The Kaplan Meier plots of structures at different voltage levels**

The Kaplan Meier plots for structures in three different voltage levels are shown in Figure 10-4

The Kaplan Meier plot for 500kV shows that all the work notifications of structures in 500kV systems are for those failed before the age of 42. From the Inventory database, the earliest installation year for 500kV structures is 1965. All the 500kV structures are installed

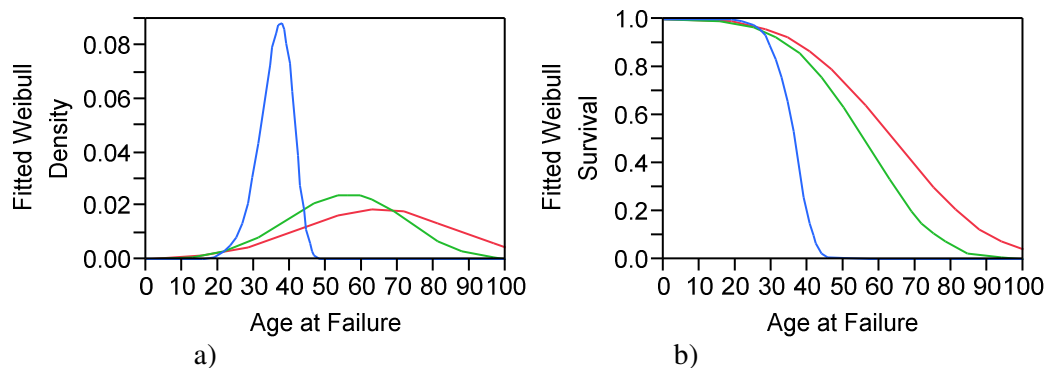
**Figure 10-5. Fitted Weibull probability density functions and survival curves for structures at different voltage levels**

The fitted Weibull probability density functions for structures at different voltage levels and their corresponding survive curves are shown in Figure 10-5a and 10-5b, respectively.

Between the structures of 115kV system and 230kV systems, it is shown in Figure 10-5 that the structures in 115kV systems tend to fail at a later age than 230kV systems; and it is shown in Figure 10-6 that beyond age 40, the failure rates of 230kV structures is roughly twice as high as 115kV structures.

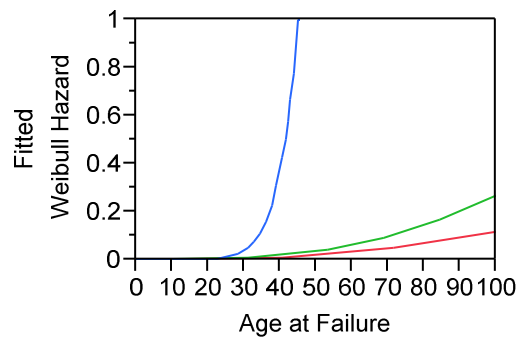
**Figure 10-6. Fitted Weibull hazard function for structures at different voltage levels.**

The pattern of structure failure in 500kV system is significantly different from the other two voltage levels. Because we are only looking at data for failed structures, the data implies that all 500kV structures would be expected to fail by age 45. This leads to a meaningless 500kV Weibull hazard plot which cannot be compared with the other voltages.

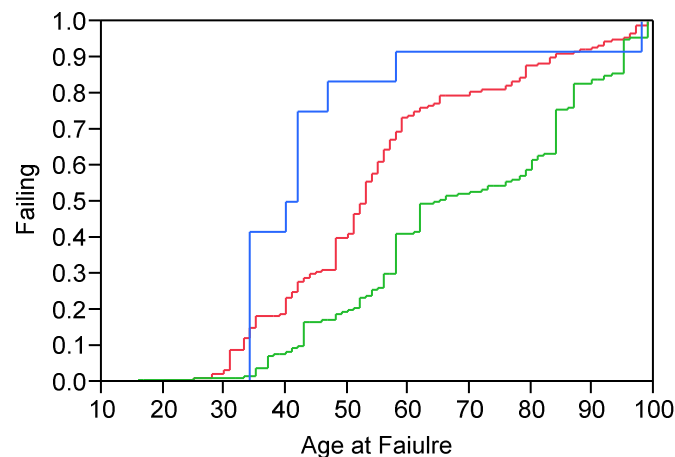
**Figure 10-7. The Kaplan Meier plots of structures of different damage types**

The Kaplan Meier plots for structures of different damage types are shown in Figure 10-7.

Due to the limited quantity of records related with structures damaged due to Worn/Aged, its curve in the Kaplan Meier plot has several obvious step-functions like zigzags. It can be a discrete version of a smooth curve, or it can be a biased curve due to biased data sample. Without additional information, the true underlying curve is not able to be identified. Therefore, special attentions should be taken to understand the results from this analysis related with the category of “Worn/Aged”.

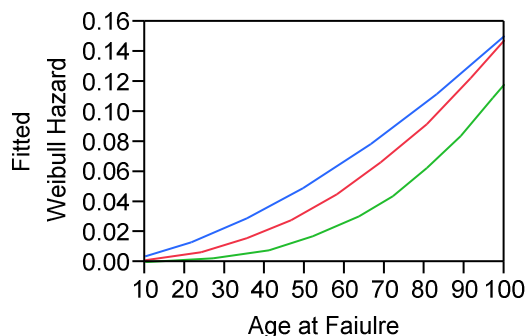
**Figure 10-9. Fitted Weibull hazard function for structures with different damage types.**

As shown in Figure 10- 9, the failure rate of structures due to “Worn/Aged” is constantly higher than the other two damage types; the failure rate of structures due to “Buckled/Bent” is slightly smaller than worn structures and the difference gets smaller at older ages. The failure rate of structures due to “Rusted” is smaller than the other two damage categories at all ages.

Worn/Aged is reported most frequently and at younger ages, Rusted is reported at the lowest rate and occurs at older ages, and Buckled/Bent is in the middle both in frequency and age.
